PRE-CERCLIS SCREENING ASSESSMENT

Loewenthal Metals Corp. 947 W. Cullerton Street, Chicago, Illinois

Prepared by:
Illinois Environmental Protection Agency
Bureau of Land
Office of Site Evaluation

August 31, 2006

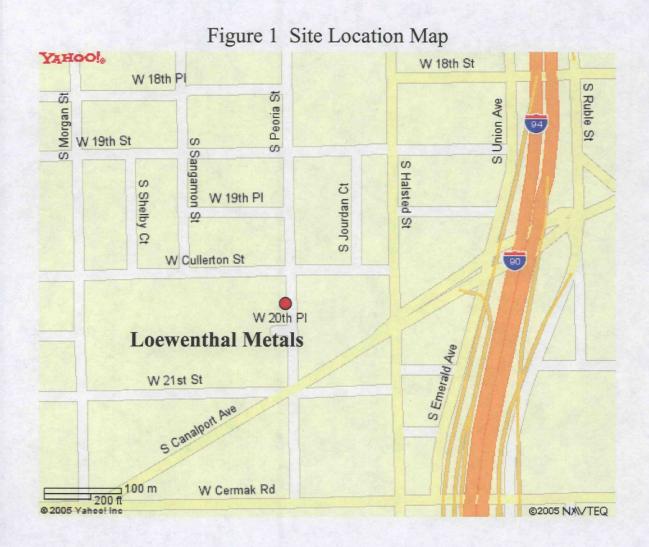
Figure 2 XRF Locations

During the July 15th site inspection, a Niton X-Ray Fluorescence (XRF) analyzer was utilized to collect inorganic data to determine if any potential hazards can be associated with past operations of the lead smelter. Twelve XRF readings were collected from random locations (Figure 2). These readings revealed elevated levels of arsenic, lead, copper, manganese and zinc. These contaminants were found to be in excess of three times the background limits. Lead was found in excess of 400 parts per million (ppm). There are no established Removal Action Levels for lead. Many times if lead exceeds 400 ppm (set forth in Tiered Approach to Corrective Action Objectives, Tier I Values) then these areas are subject to removal actions. Background limits were established using *A Summary of Selected Background Conditions for Inorganics in Soil* (Ref. 8). These XRF readings are documented in Table 1.

XRF readings were collected in various areas of the site (Fig 2). These readings were collected to determine if inorganic contamination was present in the surface soils of the site. Surface soils with contamination could affect the individuals utilizing the area for possible recreational purposes and also pedestrians using the area as a sidewalk.

elevated. Three times the background level of zinc was found in XRF 7, 9-11 and 13-16.

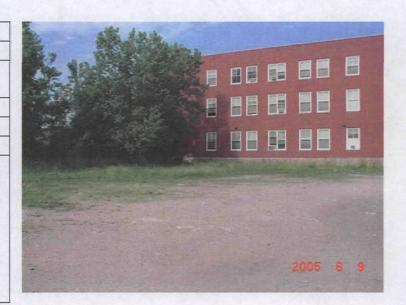
Photo No. 1

There is a residential apartment complex located directly to the west of the site (photo 1, page 11), with residential homes found adjacent (north) of the site (photos 6, 7 and 8, page 14 and 15). Rail road tracks are present on the east side of the site, followed by residential homes (photo 4, page 13).

Comments: Photo taken of vacant lot where former smelter used to be. As can be seen, lot is unvegetated and used for parking/possibly for pick up ball games. Low Rent housing in the background.

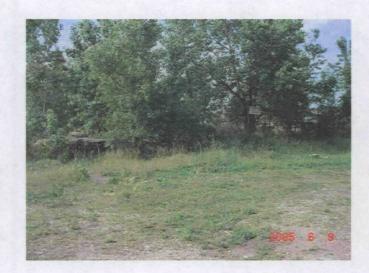
Photo No. 2

Comments: Photo taken from middle of lot. There is a concrete structure present at the back of the lot.
Railroad tracks are present

in the trees also.

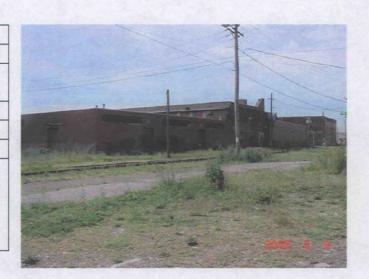
Direction of Photo: SE
Comments: Photo taken
from vacant lot, looking
down the railroad tracks.
Industrial complexes in the
area.

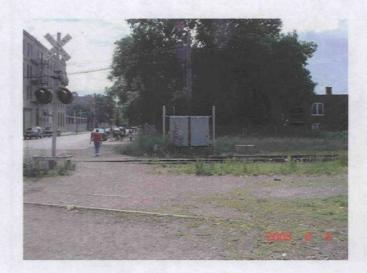
Photo No. 4

Direction of Photo: East
Comments: Photo taken
from the lot looking east.
Beyond the RR tracks are
residential homes and a
school on the far corner.
Many people walking on the
site (no sidewalk) to and
from school.

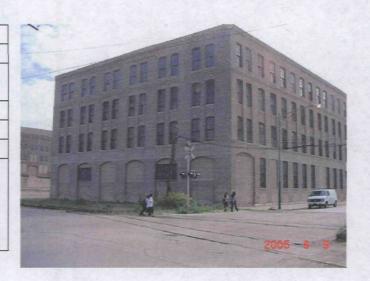
Photo No. 5

Comments: Photo taken of building across the street.
Unsure as to what this building is used for. But the building looks taken care of.

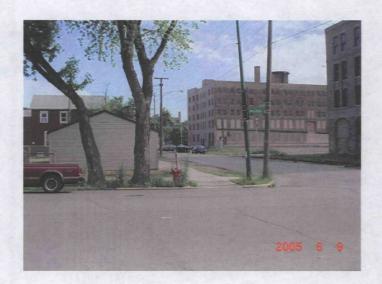
Photo No. 6

Comments: Photo taken from Cullerton looking north. Residential and industrial complexes present.

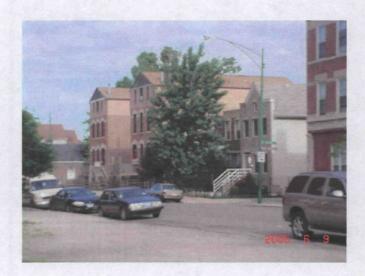
Photo No. 8

Comments: Photo taken of more residential buildings further down the street from the former smelter.

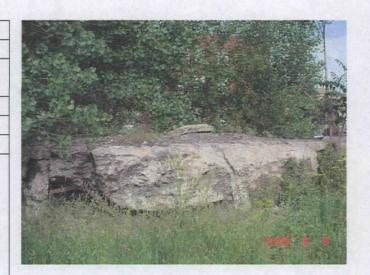
Photo No. 9

Comments: Photo taken of the concrete platform located near the southern portion of the site. It is unclear if this structure was from the smelter or if some other type of building used for railroad purposes.

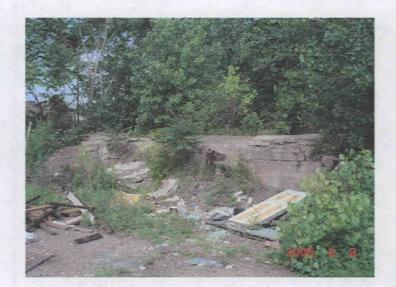
Photo No. 10

A reconnaissance trip was taken on July 15, 2006 to verify the conditions and locations of the former Loewenthal Metals Corporation. The site is presently an empty lot with a concrete platform in the southern portion of the site. There is also evidence of open dumping on the property (photo 10, page 16). A new residential complex has recently been built just west of the vacant lot (photo 1, page 13). To the east of the lot are railroad tracks followed by residential homes. The site is partially vegetated with exposed gravel and soil. Upon arriving at the site, it was determined that the southern edge of the property is being used for a walkway for children to and from school. There is not a sidewalk on the edge of this property. The presence of a tent/home-made structure near the south portion of the site indicated that the site is also being utilized by transient individuals.

Comments: Photo taken of the concrete platform. As you can see there is a dumping problem also in this area.

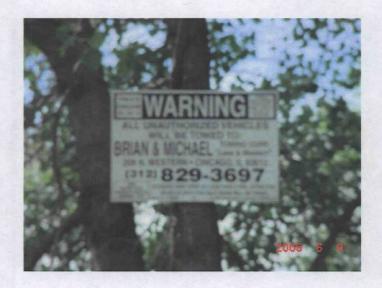
Date: 6/9/05
Time: 9:00 AM
Photo Taken By: Lance L.
Range
Roll No. NA
Photo No. 11
Direction of Photo: South
Comments: Photo taken of the sign warning of parking onsite. Contact number for the towing company.
